Inspect It Right

Home Inspection Report

123 MAIN STREET, ANYTOWN USA
Inspection prepared for: JOHN DOE
Inspection Date: 1/1/2010 Time: 10:00 AM
Age: 2001 Size: 2754 Sq Ft
Weather: PT CLOUDY

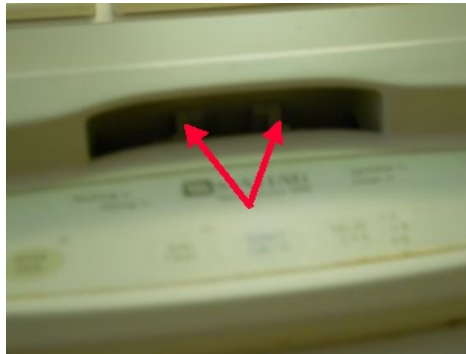
1.1. Damage to the handle of the dishwasher. Door can still be opened with missing handle.

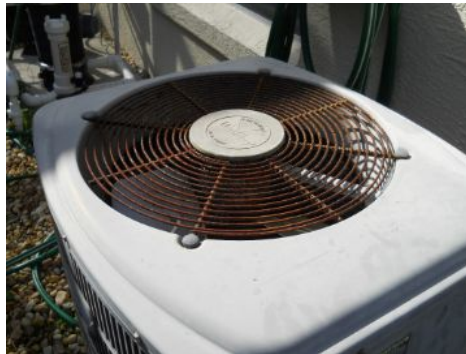
- Rust along the housing of the exterior air conditioning unit (Condenser).
- The air conditioning system was cooling at a 14 degrees difference between the return air and cold air temperatures. Recommend servicing and inspection by a licensed HVAC professional.

Rust along exterior unit

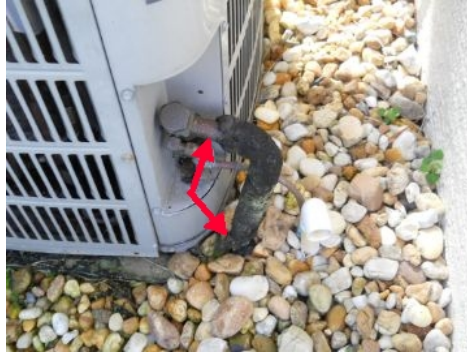
- Deterioration to the insulation along the low pressure line at the exterior unit.

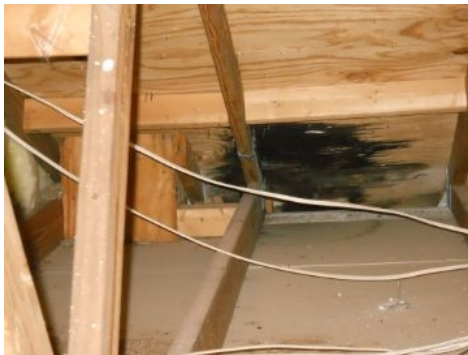
4.1. Water staining along the south slope of the garage. This area can be seen from the attic access in the garage. It appears that staining is due to a possible flashing issue. Recommend contacting a roofing contractor to determine the best repair options and cost of repairs.

Water staining and wood rot

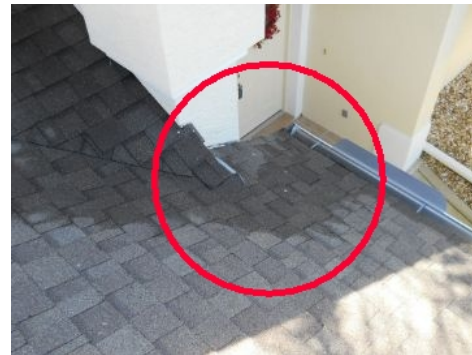
Exterior view of damage area

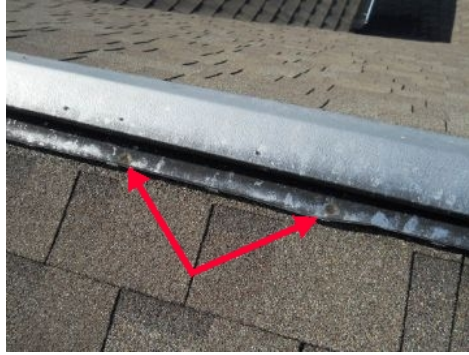
5.1. Scattered nails of the ridge vent are not sealed in. Not having nails sealed can cause nails to become loose and leak. Recommend sealing in the current nails and/or have the nails replaced with vents screws.

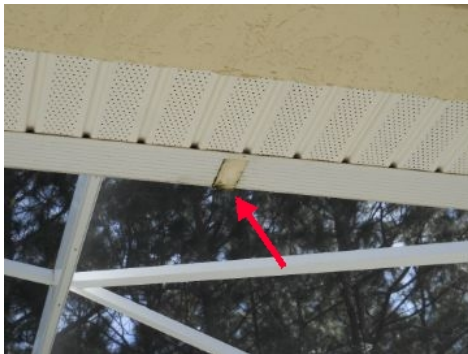
- 4.1. Gutters and/or downspouts drain on the foundation of the house. Recommend installing splash blocks or extensions to carry water away from the foundation a minimal of 3- 4 feet.
- 4.2. Scattered gutter seams are leaking. This can lead to and has caused wood rot along the wood fascia board.
- 4.3. Damage to the south endcap of the rear patio gutter.

Leaky gutter seam

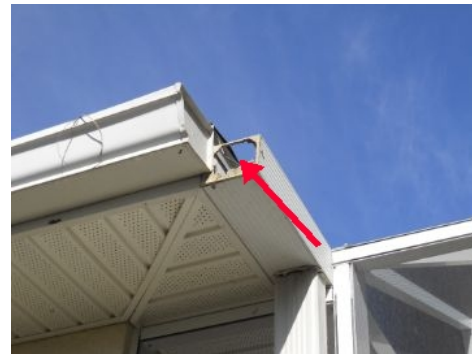
Damage south endcap

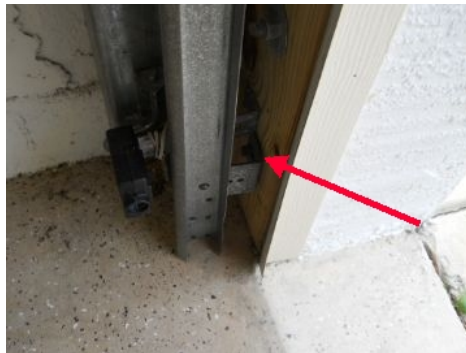
3.1. South track along the 2-car garage door has a loose bracket at the base of the track. Recommend tightening bolt along the wall.

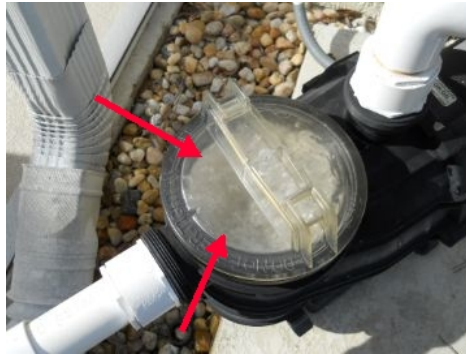
6.1. Minor leak at the lid on the top of the pool pump. This is allowing air into the pool pump and could be due to a worn gasket at the lid. Service from a pool professional is recommended.
